Effect of glue-line thickness and manufacturing defects on pull-out behavior of glued-in rods

Bo-Han Xu^{a,*}, Jin-Hua Guo^a, Abdelhamid Bouchaïr^b

Abstract

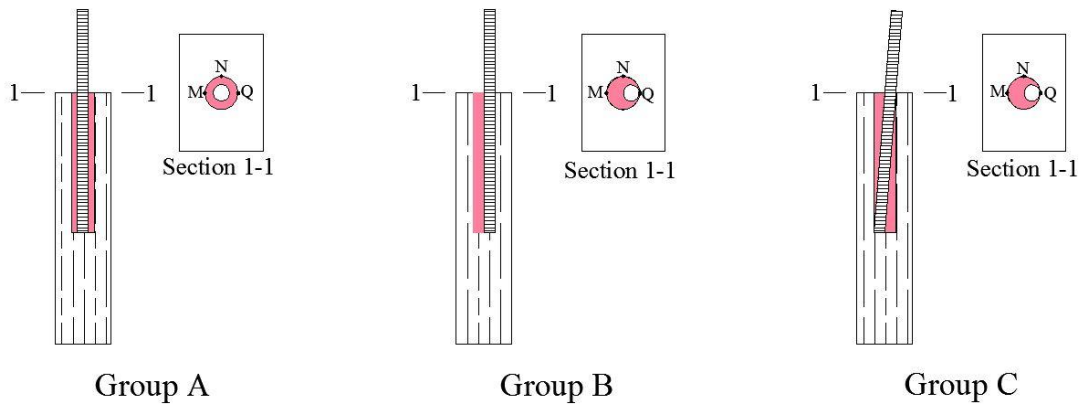
Three groups of glued-in rods specimens were tested (Fig. 1): centric position of rod in hole (Group A), eccentric position of rod in hole (Group B) and inclined setting of rod in hole (Group C). The adhesive thickness usually varies between 0.5 mm and 3 mm, the specimens in each group were manufactured with 1 mm, 2 mm and 3 mm glue-line thickness. Therefore, there are 9 series of specimens in total and three repetitions for each series were prepared. Each series is identified by a letter and a figure, letter represents the position of rod in hole and figure represents the glue-line thickness. For example, A1 represents the specimen of Group A with 1 mm glue-line thickness.

Fig. 1. Schematic diagram of test specimens

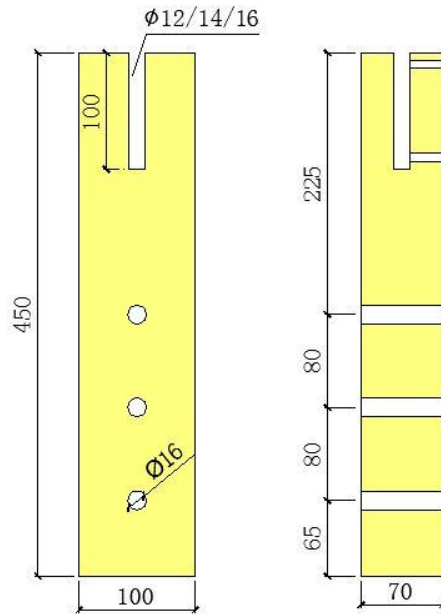
The timber members with a length of 450 mm were firstly cut from the same batch of lager glulam beam. Then, holes with diameter of 12 mm, 14 mm, 16 mm were drilled parallel to the grain at one end of timber members, to realize 1 mm, 2 mm, 3 mm glue-line thickness. Three additional holes with 16 mm diameter were drilled into the lower sections of the specimens to attach the specimens to the testing apparatus by steel bolts. In addition, adhesive injection hole and overflow hole were also drilled to assure the complete and even filling of the embedment hole with adhesive and removal of air bubbles, see Fig. 2.

Fig. 2. Schematic diagram of bore holes

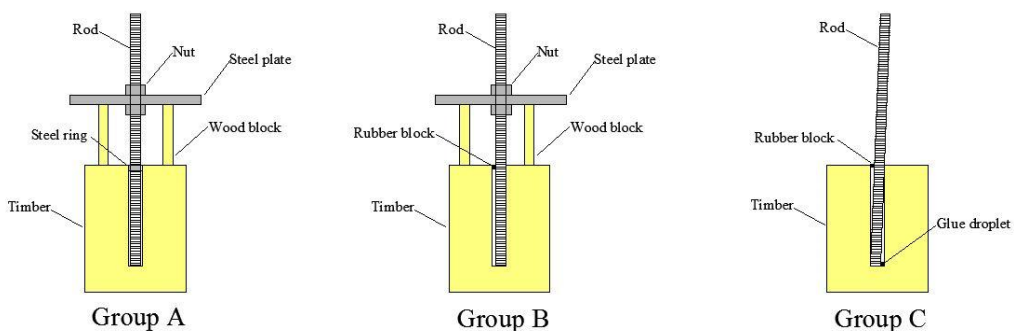
To ensure that the rod was centered in the hole of Group A specimens, the rod hole was sealed with a steel ring and the upper part of rod was fixed with a holder as shown in Fig. 3. Rods in specimens of Group B were placed completely off-set to one side of the hole by squeezing into a small rubber block between the rod and the hole. For Group C specimens, rods were placed at an angle inside the drill hole, and rods contacted with one edge of the hole by blocking a small rubber block at the top and the opposite edge of the hole by blocking a small glue droplet at the bottom. The angle to the grain is largest for the specimens with 3 mm glue-line thickness (3.4°), which results in a small but neglectable bending moment as the loads were applied parallel to the timber. All specimens were cured in a climate room with 20°C and a relative humidity of 65 % for fifteen days before testing.

Fig. 3 Schematic diagram of auxiliary holder

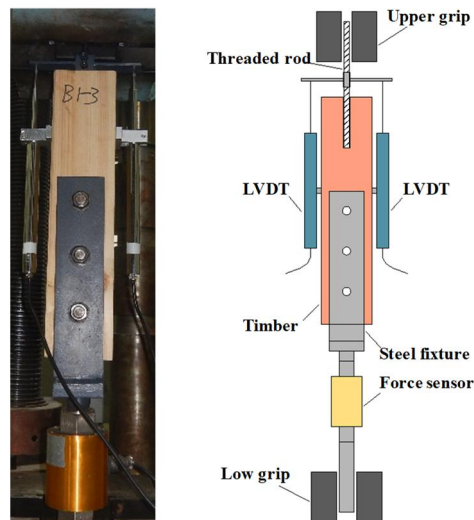
Specimens were tested under the pull-pull loading at a constant rate of 2 mm/min according to the European Standard 26891 [12]. The set-up of these experiments is shown in Fig. 4. Two LVDT displacement transducers were used to measure the relative displacement between the rod and the timber. At the same time, a force sensor is used to record the bearing capacity.

Fig. 4 Test set-up

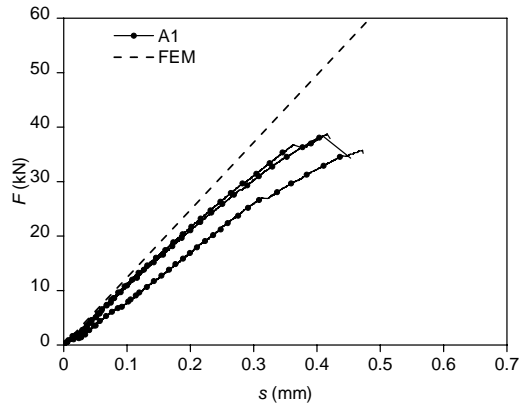
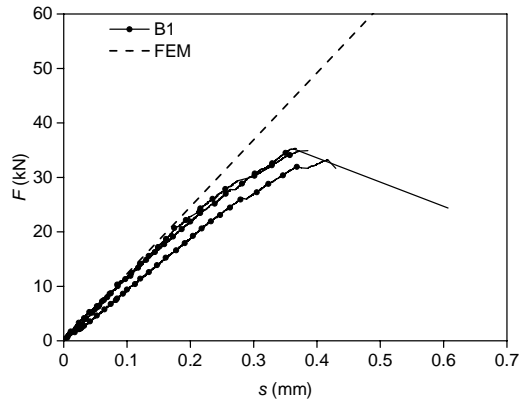
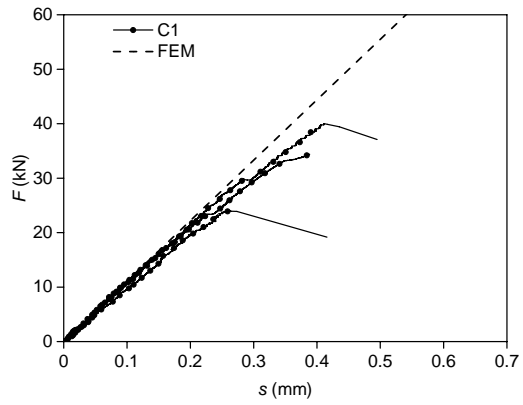
The load-slip curves of specimens are shown in Fig. 5. The load almost linearly increased with slip, and then a sudden decline appeared at a low relative displacement with audible cracks. The failure mode is shown in Fig.6. Failure mostly appeared at the timber-adhesive interface and accompanied with pull-out of wood plug. The splitting failure of the timber was only found in the specimen B3-2 (the second specimen in Group B with 3 mm glue-line thickness).

Fig. 5 Experimental and numerical load-slip curves

The load-slip curves from numerical simulations are shown in Fig. 5. The

stiffness of the finite element model is slightly higher than the experimental value. It may be because the threading of rods is not modelled, which reduces the axial stiffness compared to a smooth non-threaded rod of the same diameter [18].

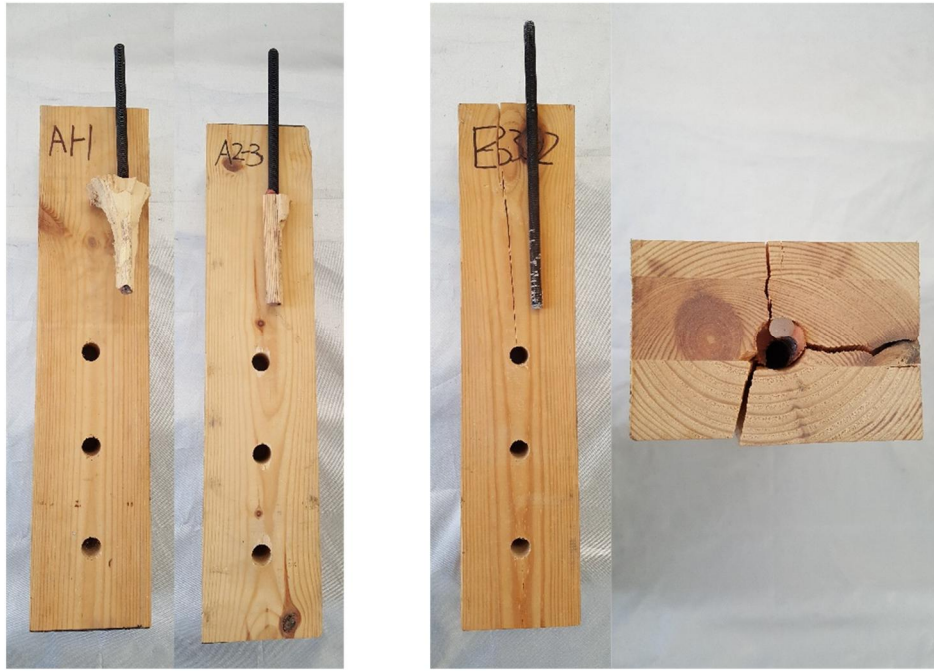
Fig. 6 Failure mode: timber-adhesive interface failure (left) and splitting failure (right)

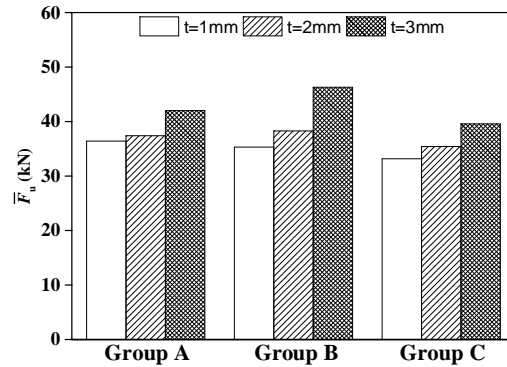
The experimental results are summarized in Table 5. Joint capacities (F_u) are defined as the load at failure. Ultimate slip (s_u) is slip corresponding to “ F_u ”. It can be found that the joint capacity and ultimate slip almost increase with the increase of the glue-line thickness. The capacity of series A2 is slightly less than that of A1, possibly because the mean density of A2 is less than that of A1. Density has been proven to be an influencing parameter on capacity of joints with glued-in rods [13, 14]. In order to normalize the comparison of capacity, the effect of density was eliminated by using Eq. 1, in which n may be assumed as 0.69 referred to [15]. Figure 7 shows the normalized capacities of joints \bar{F}_u versus glue-line thickness.

Fig. 7 Influence of glue-line thickness on joint capacity

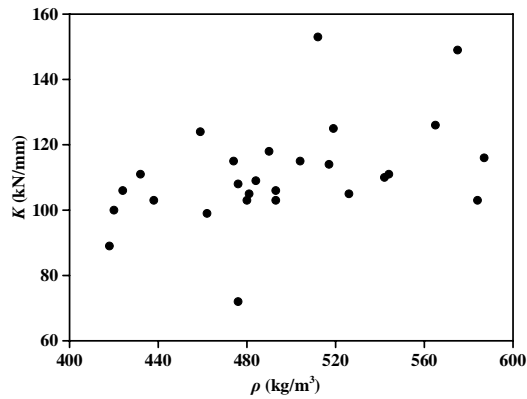
The stiffness in service (K_s) is also calculated according to EN-26891 [12], which is much larger than the value (2.78 KN/mm) calculated according to Eurocode5 draft [16]. The stiffness in service is not significantly related to glue-line thickness and positioning defect, however, it has a relatively weak correlation with density, see Fig. 8.

Fig. 8 Relationship between density (ρ) and joint stiffness (K)

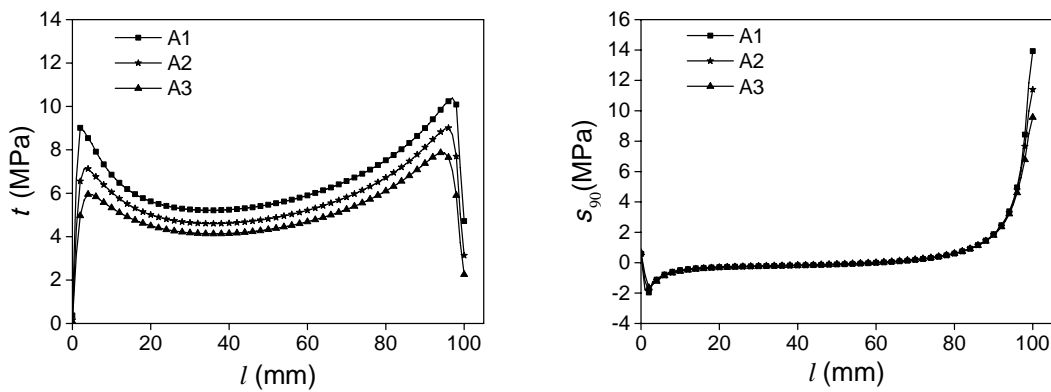
Fig.10 shows the distribution of shear stress parallel to grain and stress perpendicular to grain along the glue-line for group A at the load of 30 kN. The origin of abscissa coordinate “0” corresponds to the bottom of the bore. Shear stress peaks appear near both ends and the highest tensile stress perpendicular to grain appears on top of bore. Stress decreases with increasing glue-line thickness, it explains the joint capacity increase with the increase of the glue-line thickness

Fig. 10 Distribution of shear stress parallel to grain (left) and normal stress perpendicular to grain (right) along the glue-line

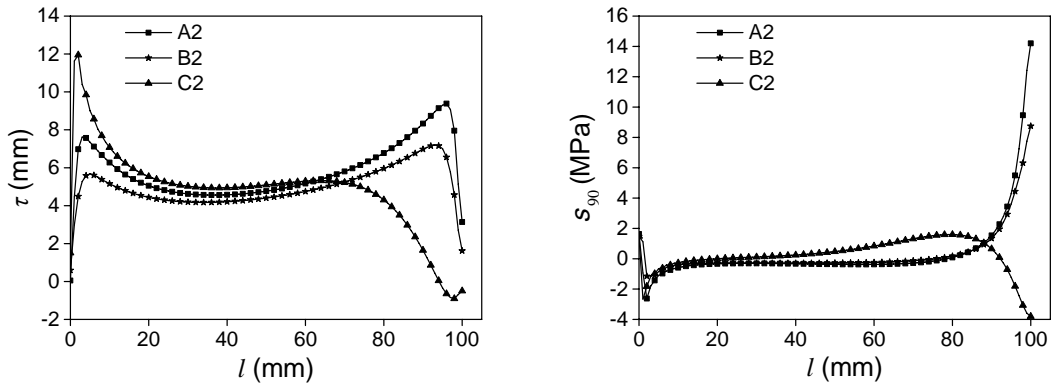
Figs.11-13 show the distribution of shear stress parallel to grain and stress perpendicular to grain along the glue-line through point “M”, “N” and “Q”, respectively, for the specimens with 2 mm glue-line thickness at the load of 30 kN. Due to additional bending moment, shear stress near the loaded end through point “M” in series C2 is less than that of the two other series, stress perpendicular to grain turns into compressive stress. The distribution of stress through point “N” is similar in three series. However, shear stress and tensile stress perpendicular to grain near the loaded end through point “Q” in series C2 is much greater than those of the two other series. It explains that the joint capacity of series C2 is less than that of the two other series.

Fig. 11 Distribution of shear stress parallel to grain (left) and normal stress perpendicular to grain (right) along the glue-line through point “M”

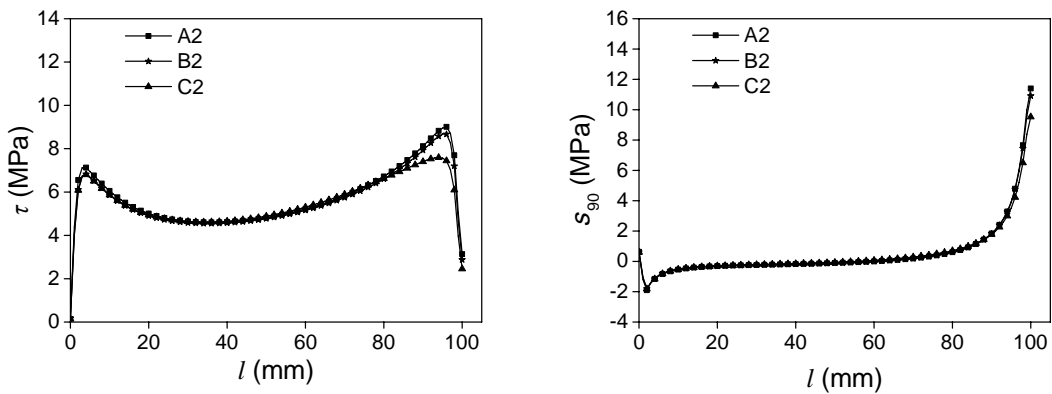
Fig. 12 Distribution of shear stress parallel to grain (left) and normal stress perpendicular to grain (right) along the anchorage length through point “N”

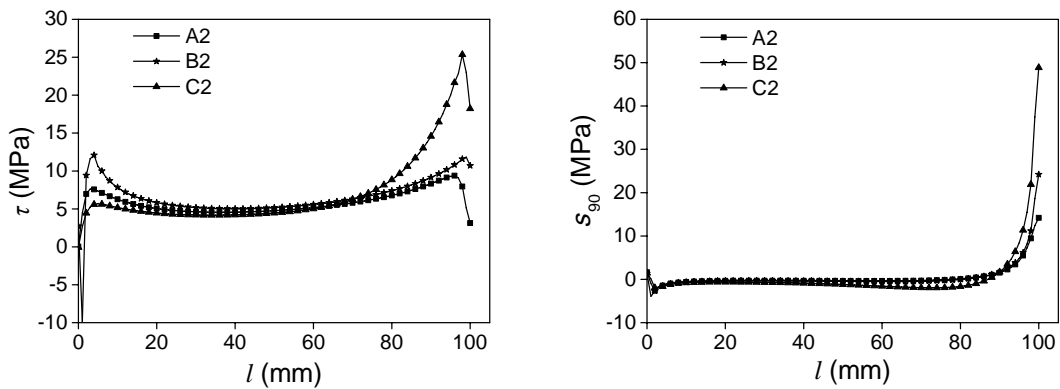
Fig. 13 Distribution of shear stress parallel to grain (left) and normal stress perpendicular to grain (right) along the anchorage length through point “Q”

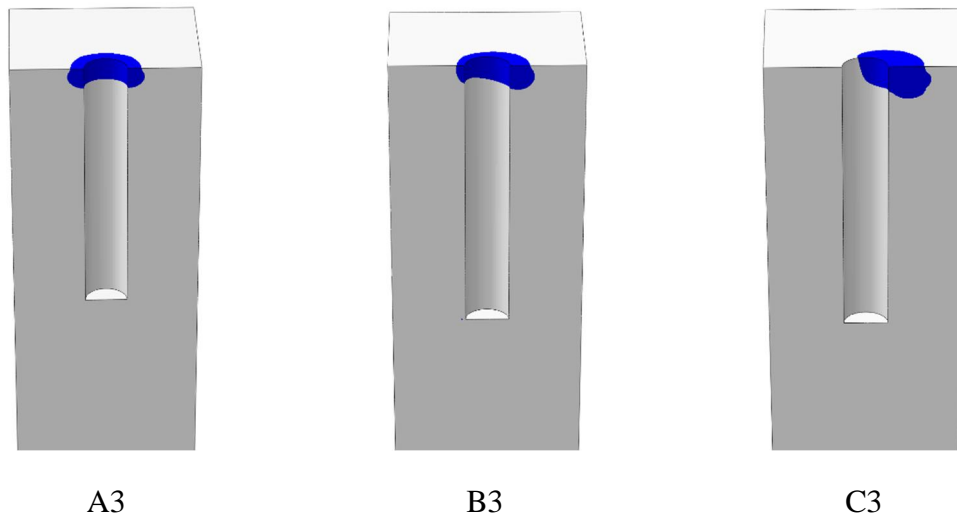
Figs. 14 and 15 show the zone where the shear stress parallel to grain and stress perpendicular to grain exceeds their strength limit, respectively, for the specimens

with 3 mm glue-line thickness at the load of 30 kN. It can be seen that the brittle failure always initiate close to the top of the bore.

Fig. 14 Contour plot of tensile stress perpendicular to grain exceeding strength limit

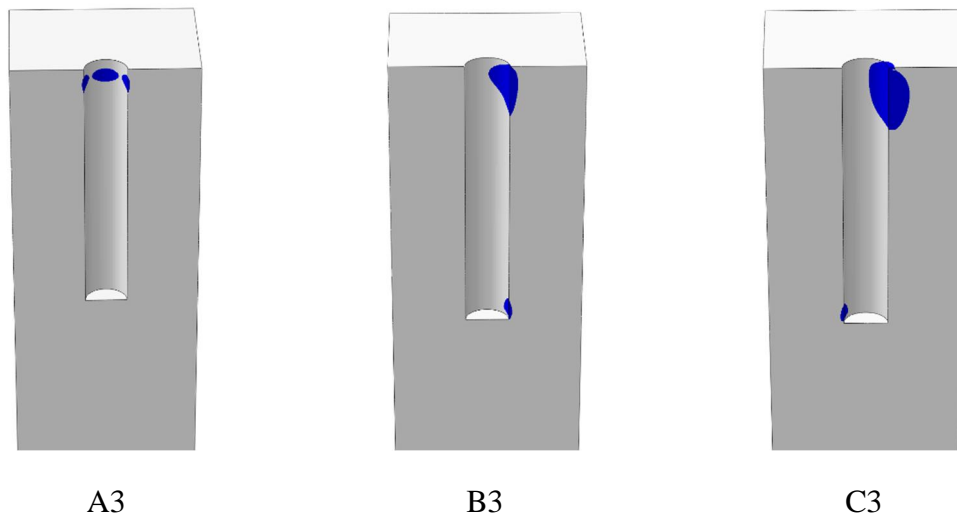
Fig. 15 Contour plot of shear stress parallel to grain exceeding strength limit
